Durability of Concrete Structures – Inspection of Lock Chambers

S. Kubens¹, J.M. Lozano-Valcarcel², T. Kränkel², A. Rahimi³, C. Müller¹ & C. Gehlen²

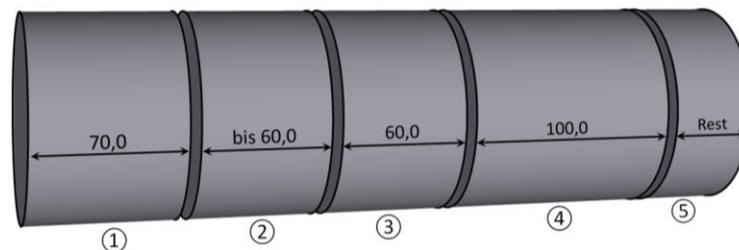
Laboratory tests were carried out on concrete cores taken from the chamber walls. Structural and durability parameters were determined on sections of those cores (see Figure 2). The first section (1) had a length of 70 mm and was used to determine the freeze-thaw resistance or alternatively the splitting tensile strength. The second section (2) often contained steel rebars and could not be used for testing. If no steel was present this core section could be used for additional testing. The third section (3) had a length of 60 mm and was used for the assessment of the air-void system in hardened concrete. The fourth section (4) had a length of 100 mm and was taken for the compressive strength test. This article covers only the investigation of air-void system in hardened concrete.

Figure 2. Schematic draft of a concrete core with test sections.

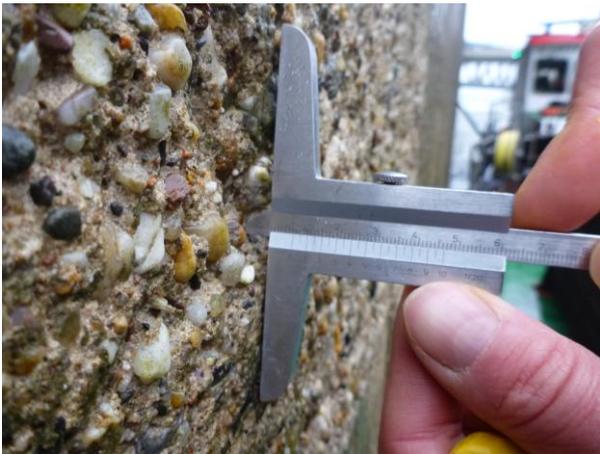
The visual inspection of the concrete surface of the chamber walls showed significant differences in concrete quality and freeze-thaw resistance. Locks 1 and 3 showed extensive damages due to freeze-thaw attack in the concrete surface subject to wet and dry cycles. Scaling depths of up to 10 mm (see Figure 3) and more could be observed with locks 1 and 3. With lock 3 the concrete surface subject to wet and dry cycles could partially be peeled off by hand (see Figure 4).

Figure 3. Measurement of scaling depth due to freeze-thaw attack at lock 3.

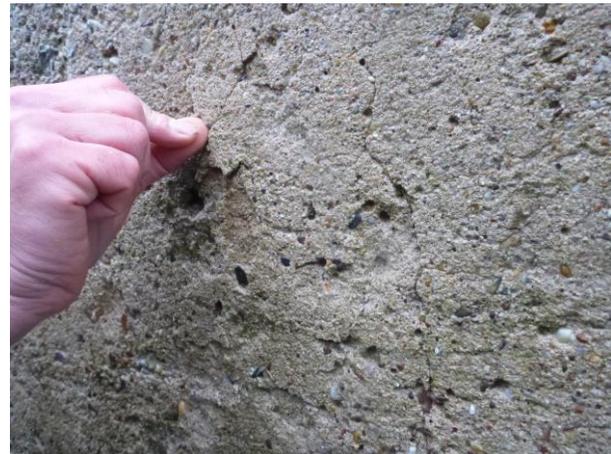
Figure 4. Concrete surface damaged by freeze-thaw attack at lock 3 can be peeled off by hand.

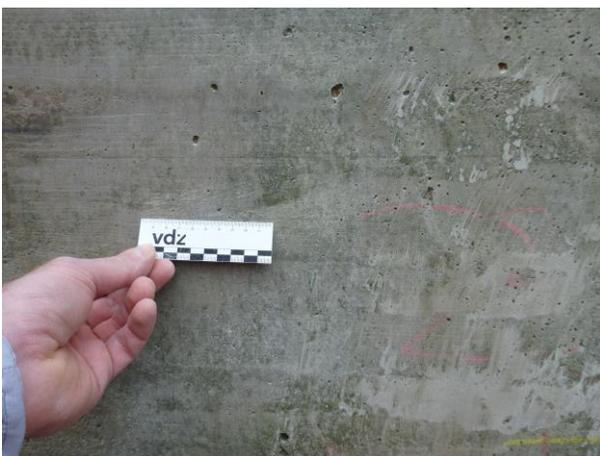
Lock 2 showed less extensive freeze-thaw damage than locks 1 and 3. The least damaged concrete surfaces due to freeze-thaw attack were observed in lock 4. Many surfaces of lock 4 still showed the formwork structure (see Figure 5) and looked as if the formwork had only recently been removed. The concrete surfaces of lock 4 were treated with a curing agent after demolding. Nevertheless, all locks showed vertical cracks, induced by constraint stress due to hydration heat development of cement, having a crack width in the toleration range of 0.1 to 0.3 mm, in a few cases up to 0.6 mm (see Figure 6).

Figure 5. After 11 years of service life lock 4 showed the least damaged concrete surfaces.

The visual inspection of the concrete surface showed huge differences in concrete quality and apparent freeze-thaw resistance. The concrete surfaces showing relatively low freeze-thaw damage (lock 4) were treated with a curing agent after demolding.

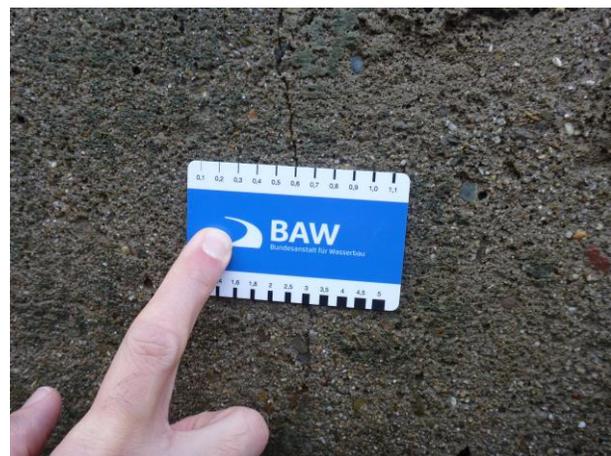
Figure 6. Vertical crack in wall of lock 1 with a crack width of up to 0.6 mm.

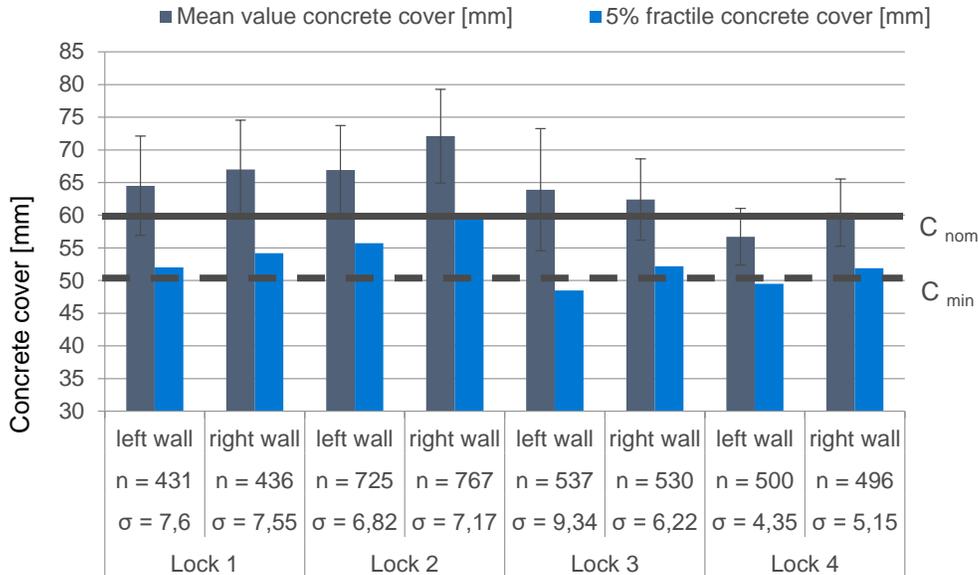
The concrete cover measurements on the four locks are shown in Figure 7. It can be seen that the minimum concrete cover and the nominal concrete cover are in good alignment with the technical specifications in the drawings (ZTV-W LB 215). The lowest standard deviation was observed with lock 4.

Figure 7. Concrete cover (mm) of locks investigated.

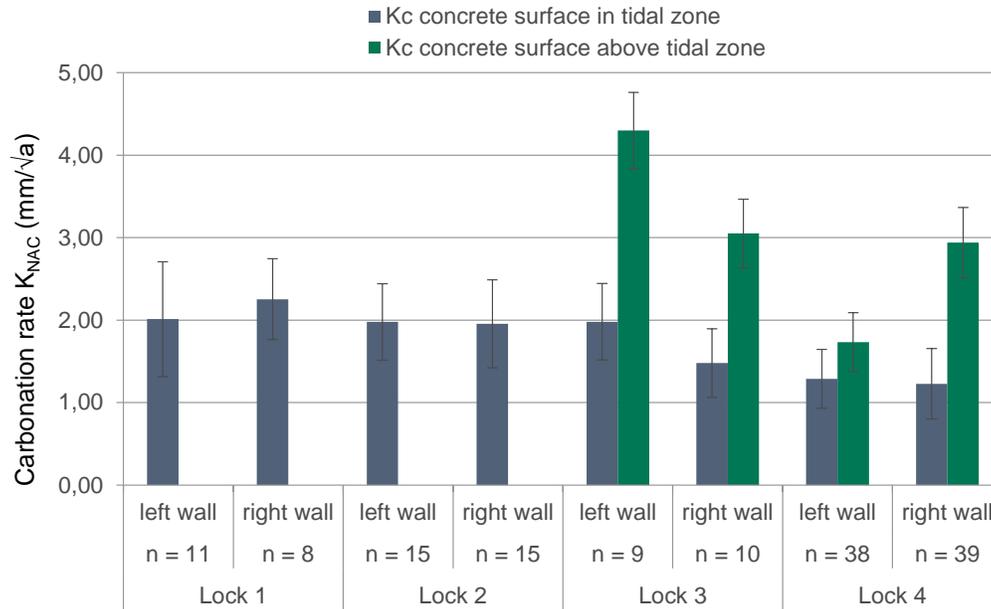
The carbonation depth was measured on freshly prepared concrete surfaces at the edges of bore holes. From these carbonation depths natural carbonation rates were calculated. The natural carbonation rates observed on the four locks are given in Figure 8. The highest carbonation rates were measured at lock 1 made with CEM III/A and basalt powder as binder at a water to cement ratio of 0.54. The lowest carbonation rates were observed at lock 4 with the same binder type and w/c-ratio. The only difference was the application of a curing agent on concrete surfaces of lock 4. From Figure 8 it can be seen that the concrete subject to wet and dry cycles (wet concrete in the tidal zone) showed lower carbonation rates than concrete not subject to wet and dry cycles (concrete above headwater level). The calculated carbonation rates were ranging from 1.2 to 4.3 mm/ \sqrt{a} . The results indicate that the moisture in the concrete prevents the transportation of CO₂ into the concrete pores and hence reduces the carbonation rate, especially in the areas subject to wet and dry cycles. The observed carbonation depths are probably largely due to the time between the completion of the structural component and the start of water exposure.

Figure 8. Natural carbonation rates (mm/√a) of locks investigated.

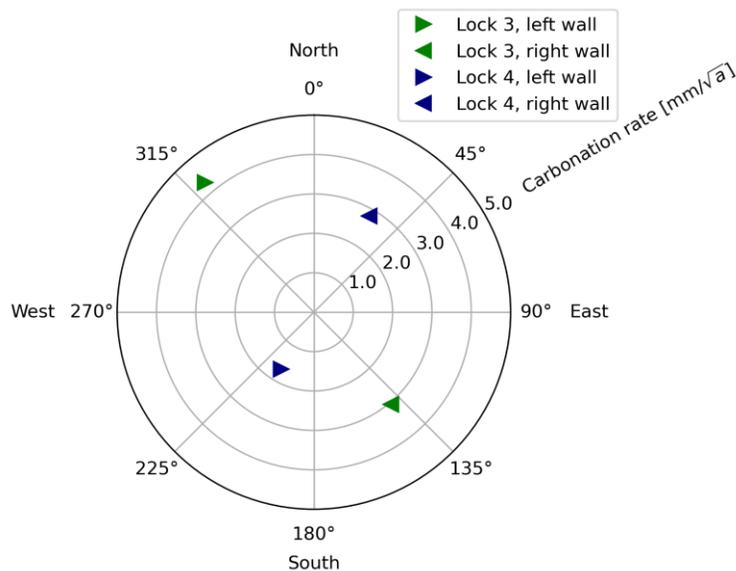
The carbonation rates were also plotted as a function of orientation (North, East, South, West). It was found that the highest carbonation rates could be observed along the West-East axis (see Figure 9). In Germany the “weather side” is usually West, meaning the rain comes usually from the Western direction. Hence, carbonation rates should, theoretically, be lowest on concrete surfaces facing West. However, this could not be observed.

Figure 9. Natural carbonation rates (mm/√a) for locks 3 and 4 as a function of orientation, for concrete above headwater level.

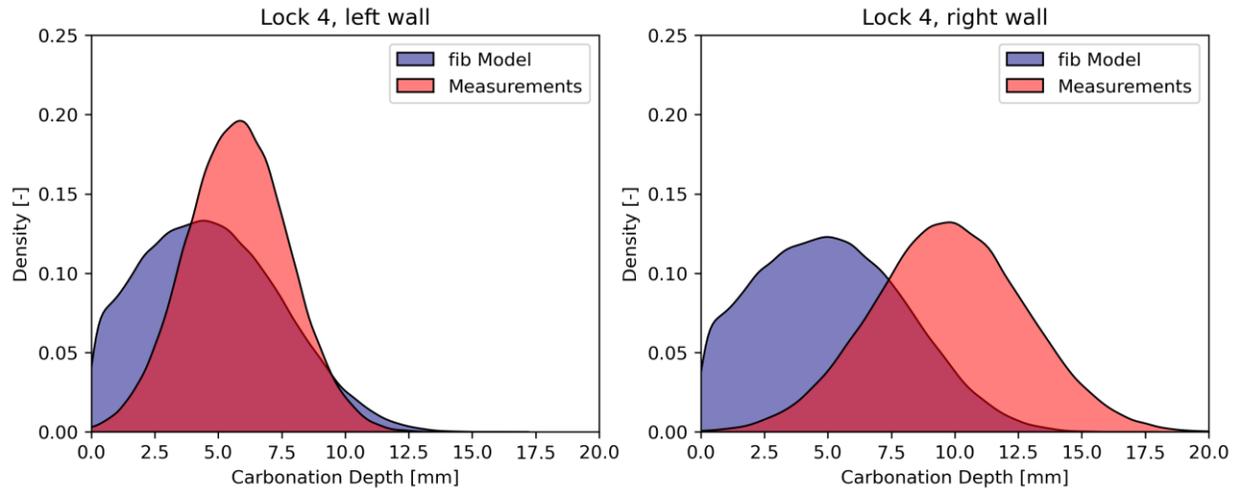
The concrete cover and carbonation depth measurements were used to estimate the remaining service life of the structure. The model variables were calculated following Gehlen (2000). Figure 10 shows the calculated (a-priori) and the measured carbonation depths at the time of inspection (11 years) for both chamber walls of lock 4. It can be seen, that the model prognosis and the inspection measurements are close to each other, though the right wall shows slightly higher carbonation depths as predicted. For this reason, both the a-priori calculated carbonation depths and the measurements were used to update the model calculation and estimate the probability of depassivation at a service life of 100 years.

Figure 10. Predicted (fib Model) vs measured carbonation depths at lock 4 above headwater level, (t = 11 years).

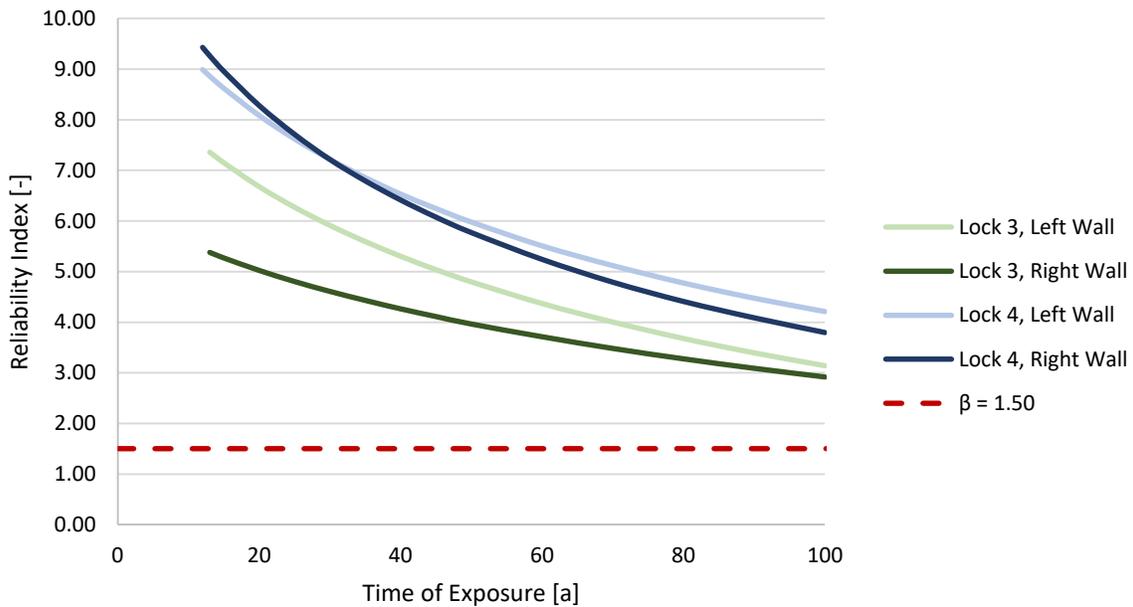
Figure 11 shows the evolution of the reliability index (β) in time for the left and right chamber walls of the locks 3 and 4. Both chamber walls of the two analysed locks achieve a target reliability index at an age of 100 years higher than the minimum set by DAFStb (2008) of 1.5. The lowest reliability index (right wall of lock 4) has a value of 2.92, which corresponds to a probability of depassivation lower than 1 %, suggesting that for these elements, carbonation-induced corrosion is of secondary concern during their targeted service life.

Figure 11. Reliability index as a function of exposure time for locks 3 and 4 (concrete above headwater level).

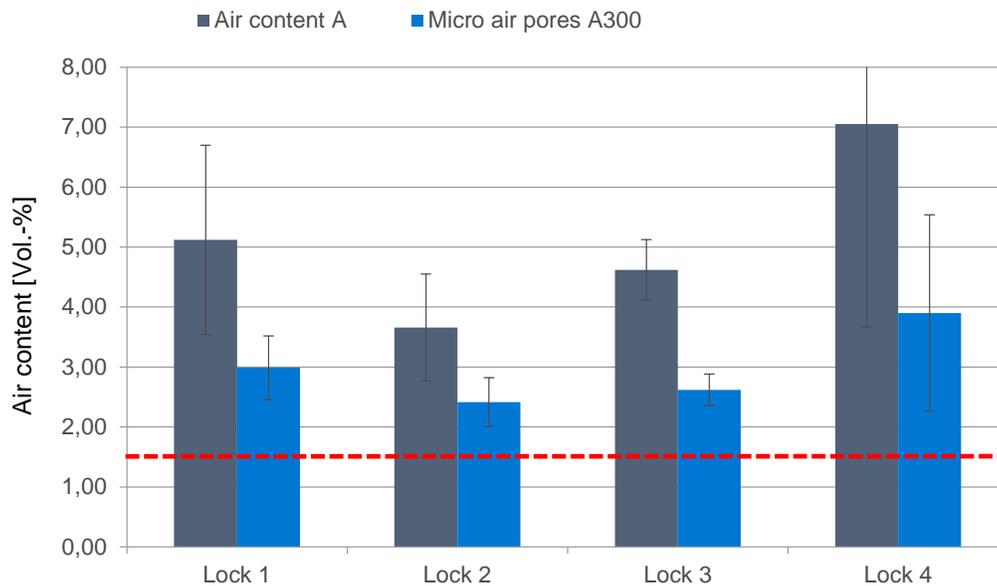
The air-void system of concrete from the chamber walls of the locks is displayed in Figure 12. The parameters were obtained on sections of concrete cores 13 to 19 cm below the surface. From Figure 12 it can be seen that the mean value for air content A was between 3.7 and 7.1 Vol.-%. The content of micro air pores ranged from 2.4 to 3.9 Vol.-% while the spacing factor L was between 0.11 and 0.16 mm (not displayed). According to ZTV Beton StB 07 (ZTV, 2007) these values characterize a freeze-thaw resistant concrete.

Figure 12. Air content A and content of micro air pores A300 (Vol.-%) of locks investigated.
